C019 Film Scanning Unit: Pick up setting

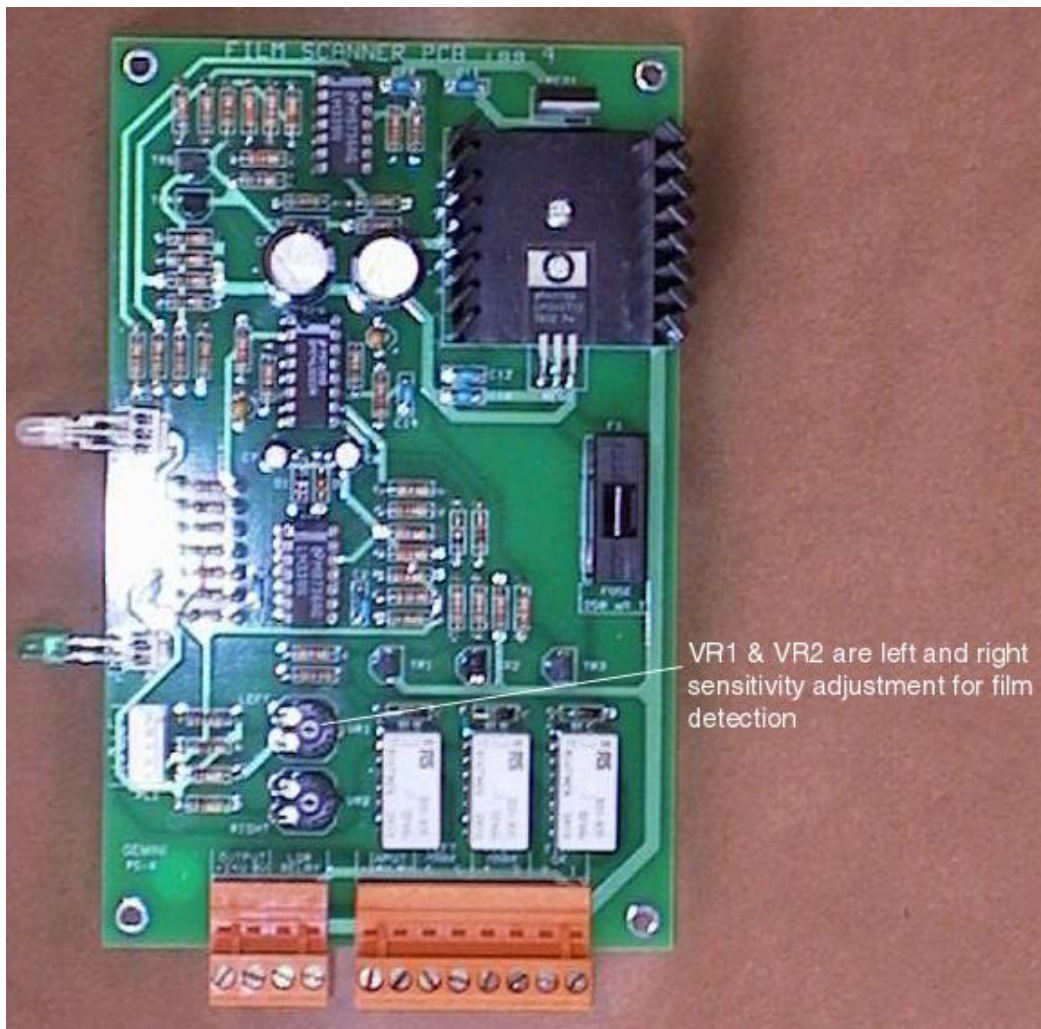
Firstly check that the pick-ups are not marked as 'RS', if so the first step would be to replace the roller assembly, as a faulty batch exists.

The sensitivity of the pick-ups is controlled by two potentiometers, situated within the C019 electronics box (the box with the 'Pulse' and 'Film Ok' LED's).

Initially use a piece of white card placed over the rollers, this will initially be detected by the pick-ups. Adjust the potentiometers until the white card is no longer detected.

Substitute the white card for a strip of silver foil, adjust potentiometers until the silver foil can be detected.
